Ontario  
Ministry of  
Labour

**A SUMMARY OF  
ACCIDENTS  
INVOLVING  
UNDERGROUND MOTOR VEHICLES  
IN  
ONTARIO MINES  
FOR THE YEAR 1994**

May 1995

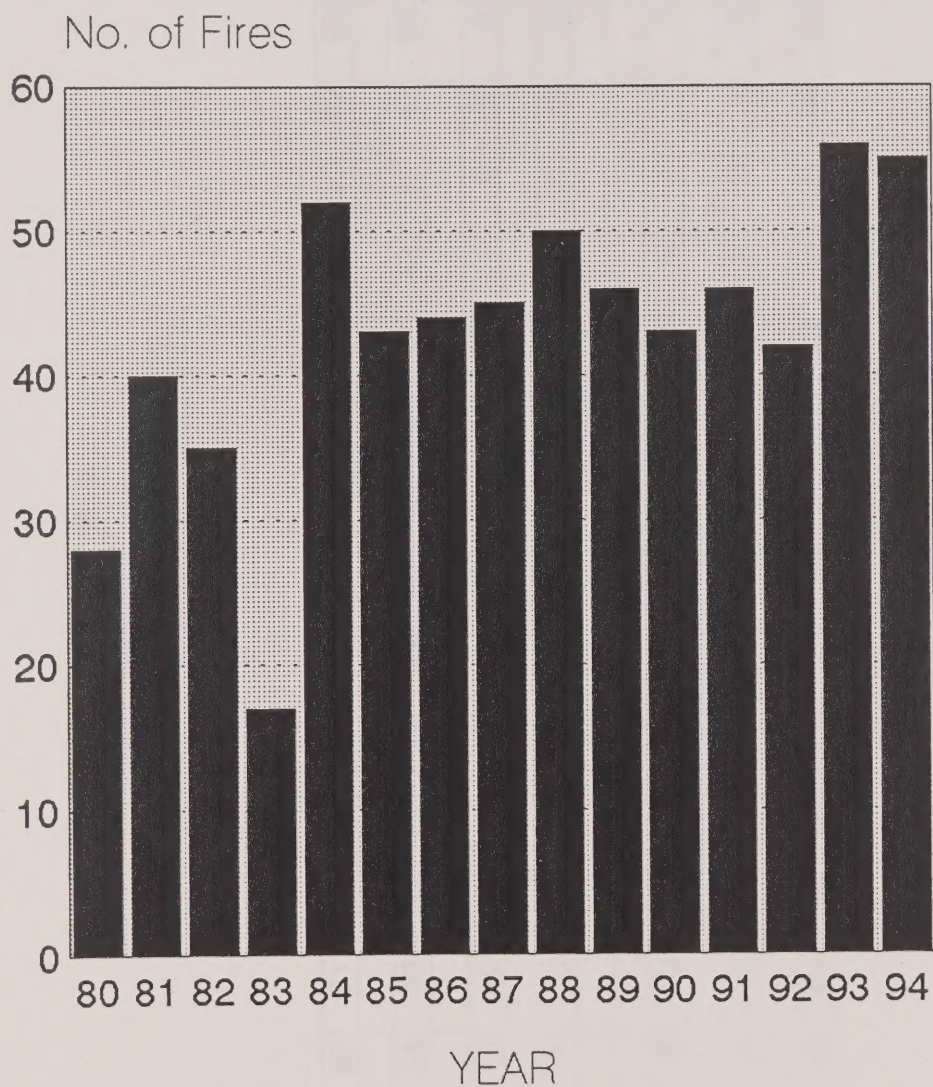
Ontario - Chart No. 1

## Total Fires for 1980-1994

TOTAL FIRES 1980 - 1994 .....	CHART 1
-------------------------------	---------

Fires continue at a high number of 55, only slightly down from the peak of 56 that occurred last year. Fires caused by overheated brakes are down to 9 from the peak of 19 reached last year and flammable fluid fires are up to 14 from the average of 8 over the last few years.

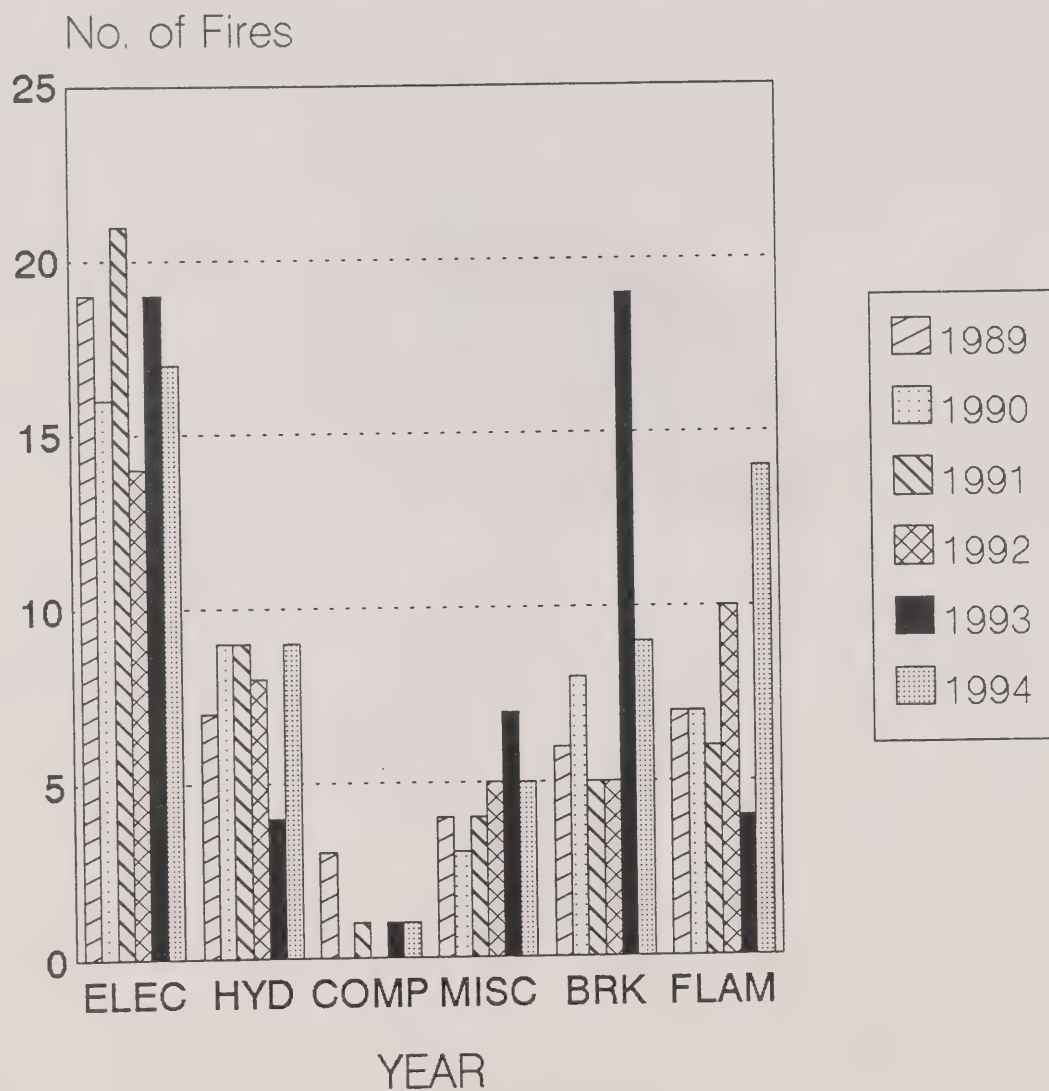
Ontario - Chart No. 2

# MOBILE VEHICLE FIRES by TYPE for 1989-1994

TYPES OF FIRES FOR 1984 - 1994 .....	TABLE 2 AND CHART 2
--------------------------------------	------------------------

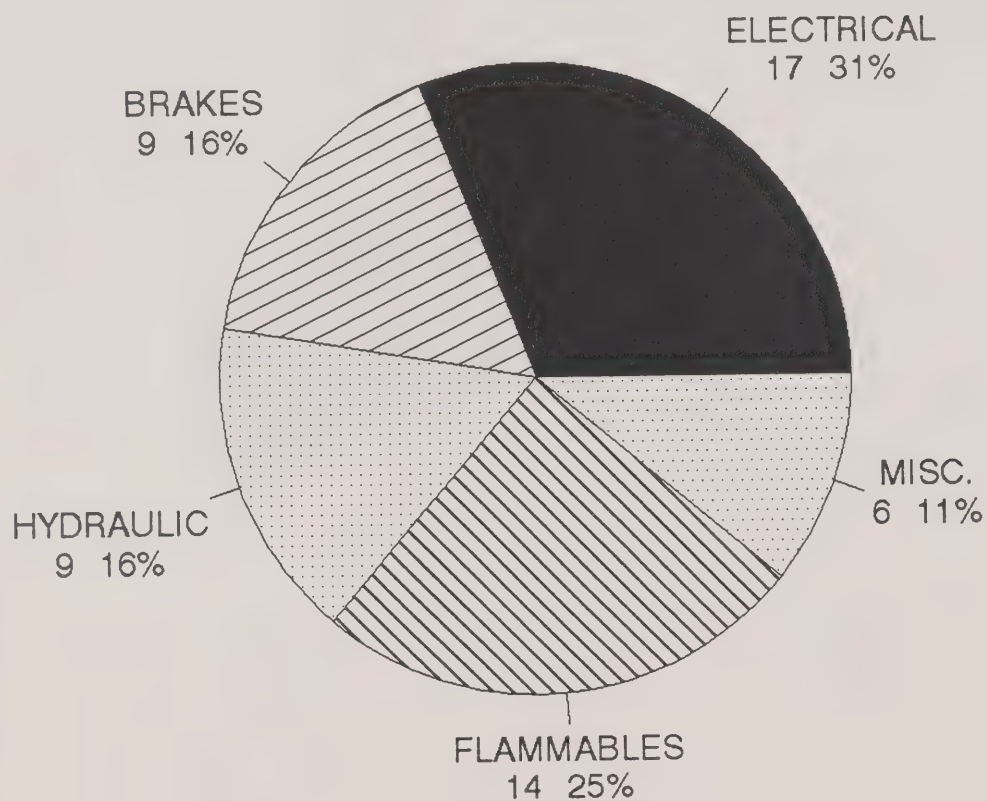
Ontario - Chart No. 3.1

# MOBILE VEHICLE FIRES

## Types of Fires - 1994

TYPES OF FIRES - 1994 .....	CHART 3.1
-----------------------------	-----------

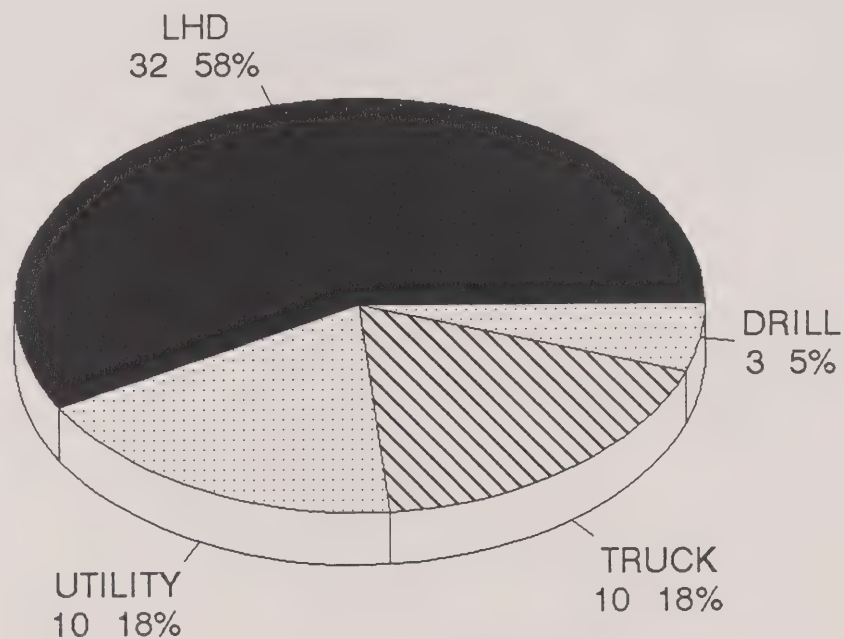
Ontario - Chart No. 3.2

# MOBILE VEHICLE FIRES

## Vehicles Involved - 1994

VEHICLES INVOLVED - 1994 .....	CHART 3.2
--------------------------------	-----------

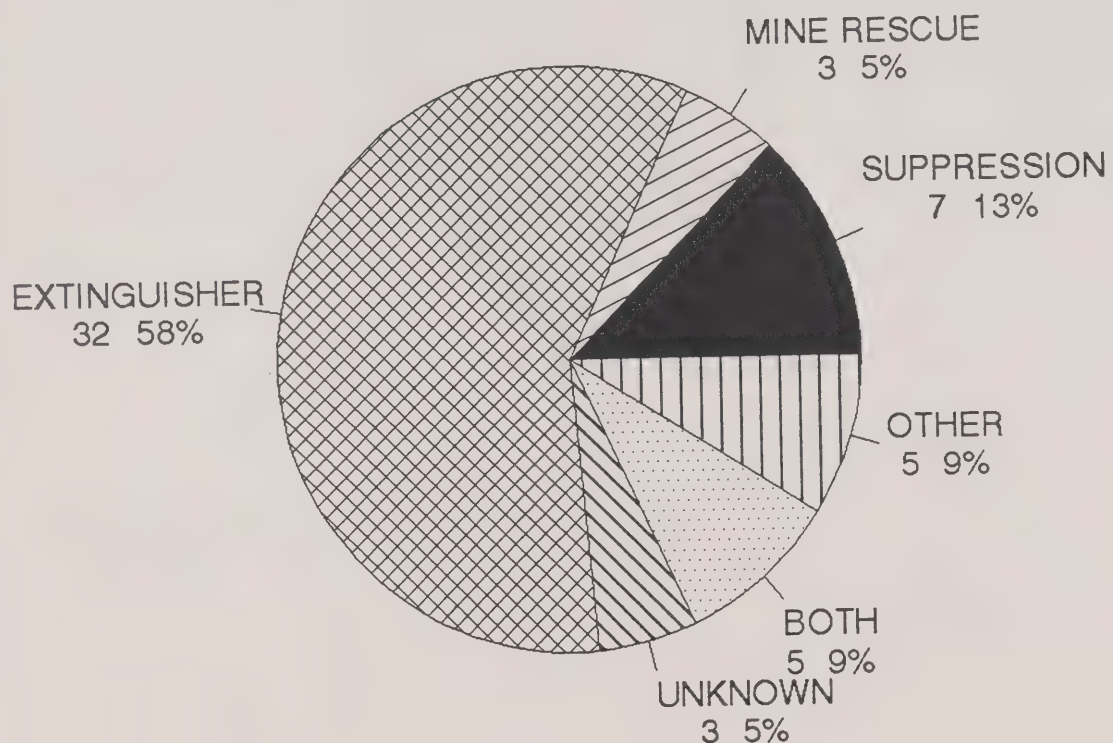
Ontario - Chart No. 3.3

# MOBILE VEHICLE FIRES – 1994

## How the Fires were Extinguished

HOW THE FIRES WERE EXTINGUISHED .....	CHART 3.3
---------------------------------------	-----------

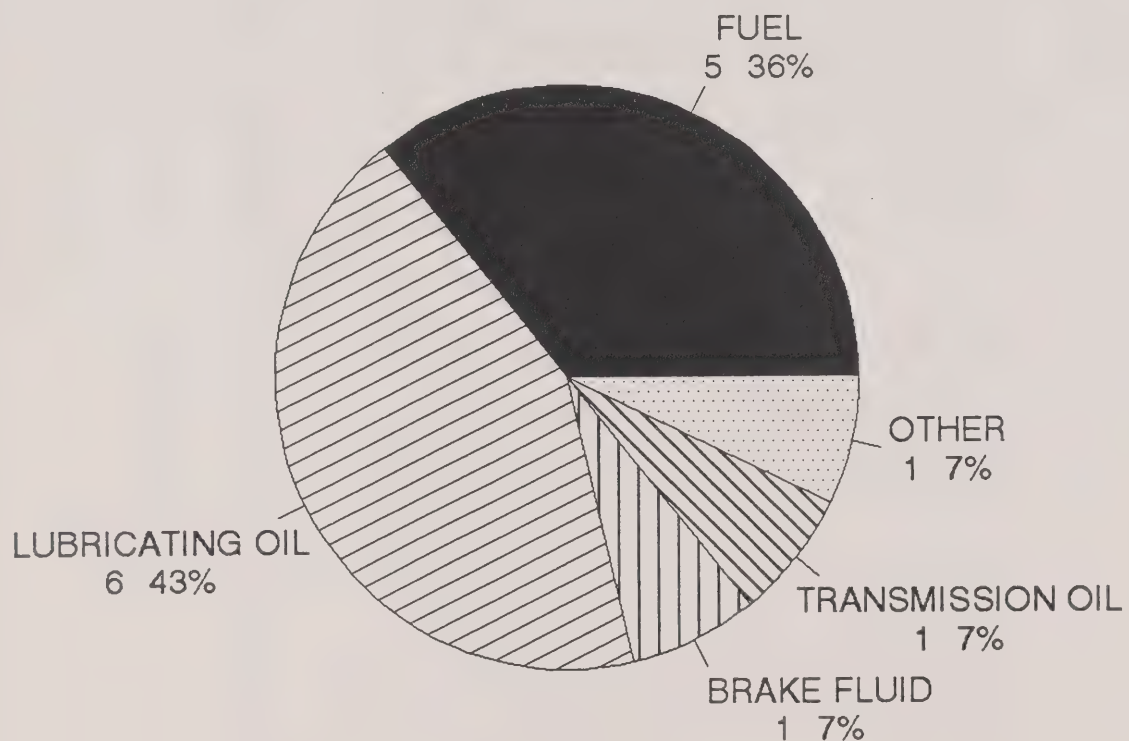
Ontario - Chart No. 3.4

# MOBILE VEHICLE FIRES – 1994

## Type of Flammable Liquid

TYPE OF FLAMMABLE LIQUID .....	CHART 3.4
--------------------------------	-----------

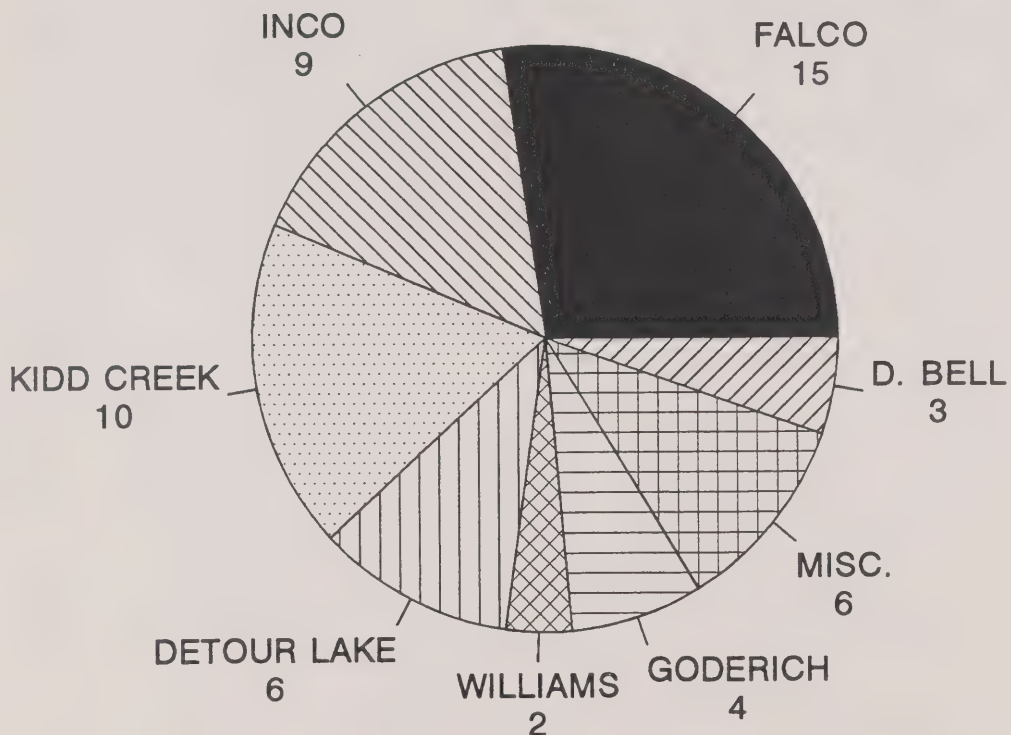
Ontario - Chart No. 4

## No. of Fires by Company - 1994

NUMBER OF FIRES BY COMPANY - 1994 .....	CHART 4
---	---------

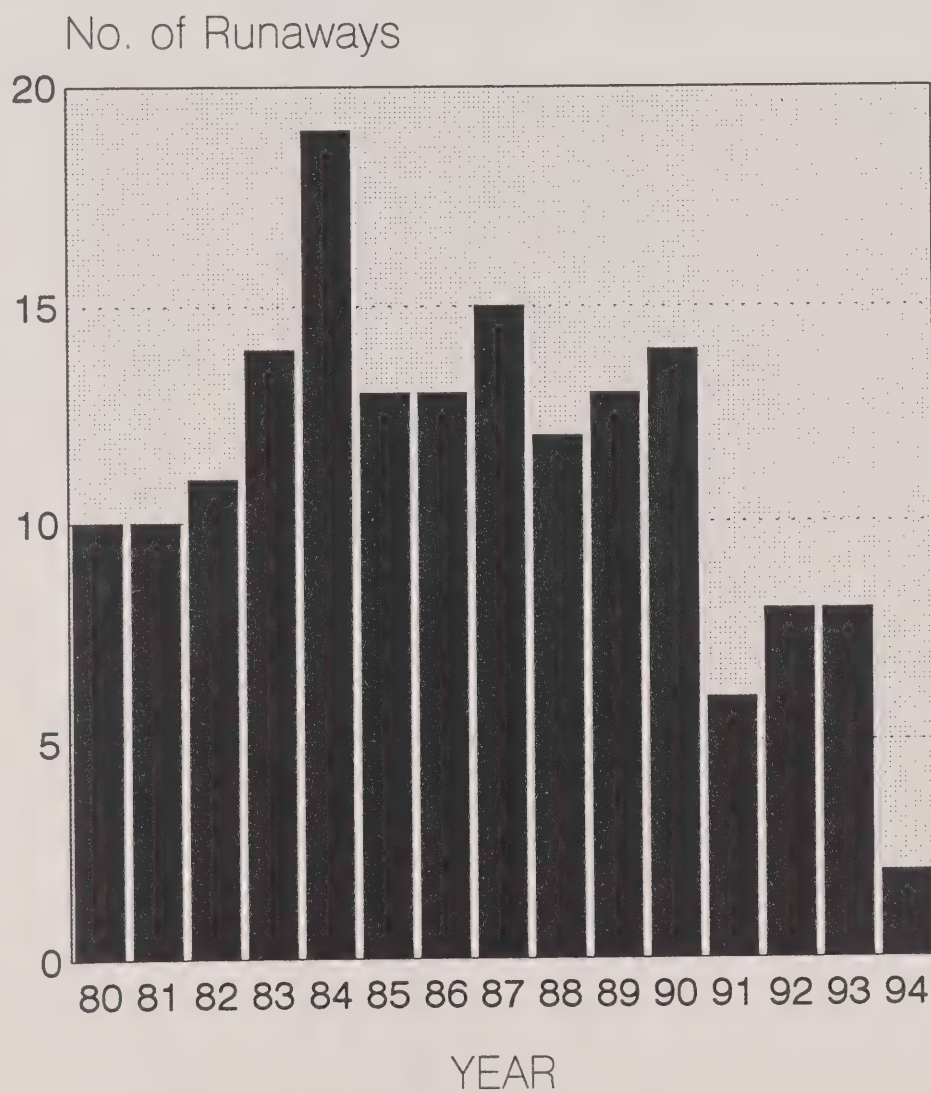
Ontario - Chart No. 5

## Runaway Accidents for 1980-1994

RUNAWAY VEHICLE ACCIDENTS FOR 1980 - 1994 .....	CHART 5
---	---------

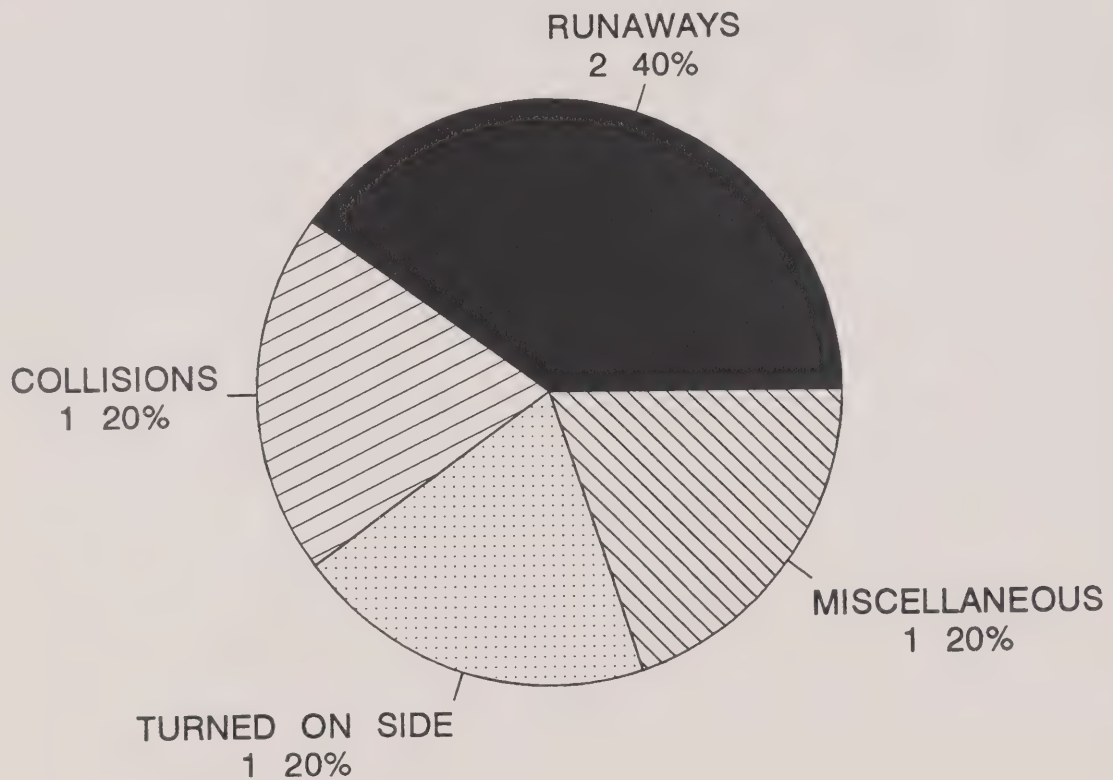
Ontario - Chart No. 6

## Types of Accidents - 1994

TYPES OF ACCIDENTS - 1994 .....	CHART 6
---------------------------------	---------
